Final report RL 2014:07e

Serious incident at Sveg Airport on May 3, 2013 involving aircraft ES-PJR of the model Jetstream 3200, operated by AS Avies.

File number L-46/13

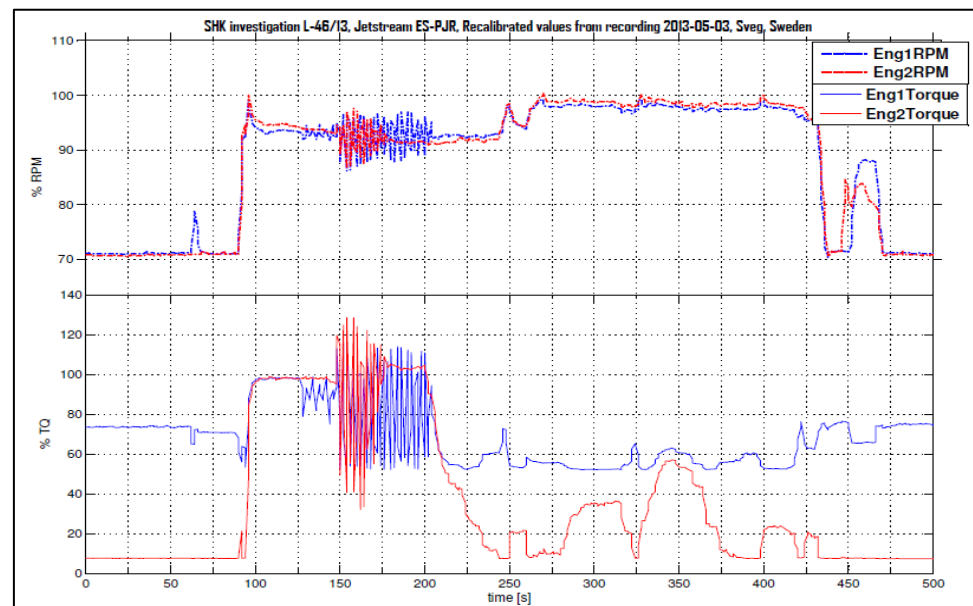
Figure 12. FDR printout of corrected RPM and Tq.

The graph shows that the RPM of both engines, at a time of roughly 90 seconds, increased from idle RPM - around 72% - to a maximum value of around 100%, to then reduce to around 95%. Thereafter, the RPM slowly decreased to around 94%. The RPM of the left engine followed roughly the same profile but was somewhat lower.

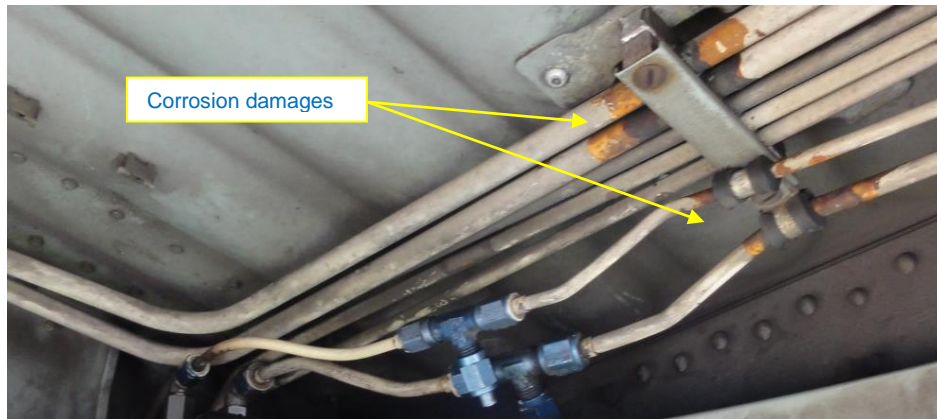
After the incident, a technical inspection of the aircraft was carried out in the presence of investigators from SHK. The investigation began with the test-run on ground. No fault or anything else abnormal could be noted. The aircraft was thereafter investigated by a certified technician with the intention of finding any technical faults or shortcomings that could have affected the sequence of events. During the investigation, corrosion damage was noted in the aircraft's tubing, see Figure 13.

Figure 13. Area in the aircraft's tubing where corrosion was found.

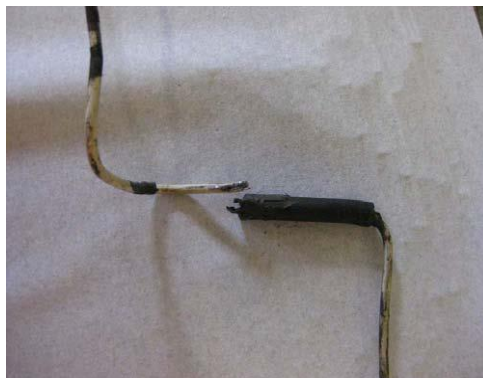
The tube connection for total air pressure at the inlet for both engines (PT2) was damaged. The pipe to the left engine was severed and provisionally repaired with a piece of rubber tubing. The tube to the right engine was leaking at one connection. When the connection was loosened, the tube burst as a result of corrosion, see Figures 14 and 15.

Figure 14. PT2 tube to the left engine.

- The effect of the leakage in the PT2 and PS5 tube on the function of the TPE331 SRL System and SRL-EGT during the circumstances in question was non-existent or negligible.
- The effect of the leakage in the PT2 and PS5 tubes on the function of the TTL System during the circumstances in question was non-existent or negligible.
- No other functions in the engines are deemed to have been affected by the defective PT2 and PS5 piping and thereby contributed to the engine disruptions.
- In summary, the defects in the PT2 and PD5 tubes are deemed not to have affected the sequence of events.

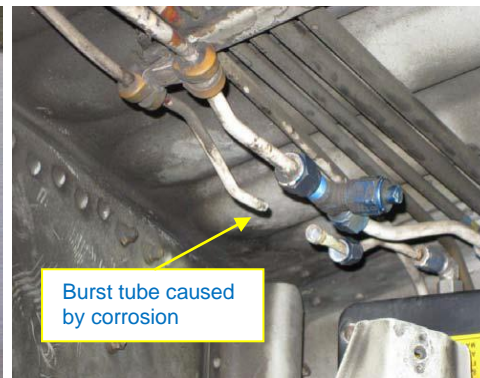
Figure 15. PT2 tube to the right engine.

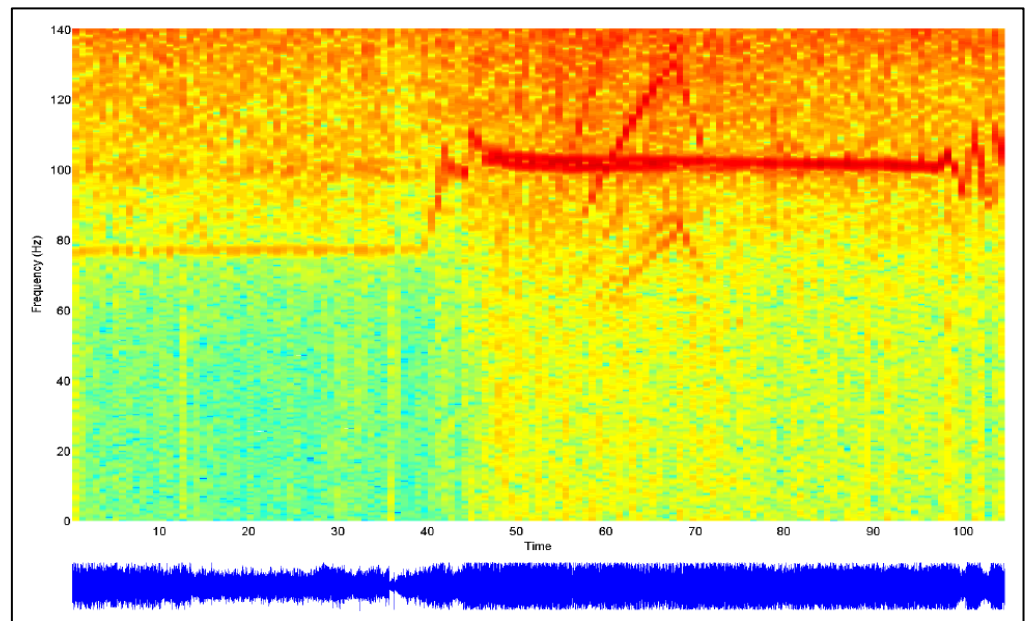
Figure 16. Spectrogram of the propeller noise during the take-off sequence.

The spectrogram shows a key note (or two almost simultaneous key notes) whose frequency increased at around 40 seconds in, from approx. 77 Hz (1155 RPM, 73 %) to approx. 109 Hz (1635 RPM, 103 %) at around 46 seconds and after two seconds decrease to 102 Hz (1530 RPM, 96 %) There after continue until 97 seconds and then gradually decrease to approx. 100 Hz (1500 RPM, 94 %). At a time of around 100 seconds, the frequency began to oscillate with increasing amplitude.

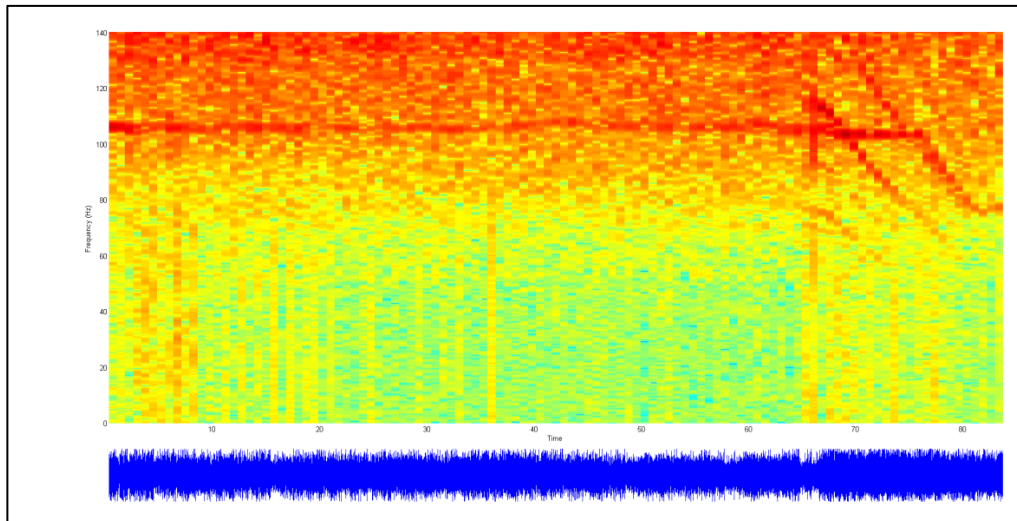
Figure 17. Spectrogram of the propeller noise during landing.

The spectrogram reveals a relatively even and stable key note of 106 Hz (1590 RPM, ~100%) which towards the end decreases quickly.

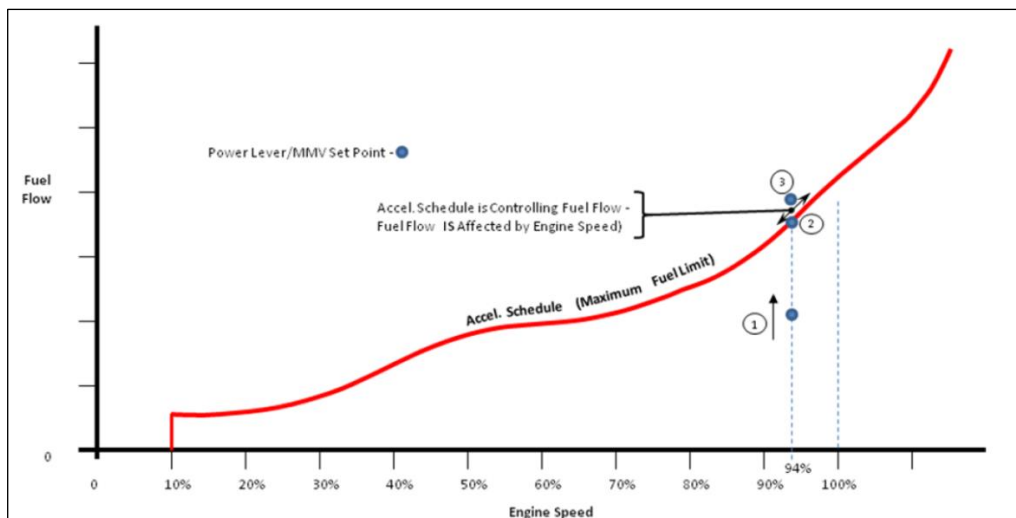
If the Power Lever, at the same RPM, is advanced to take off power, as Point 3, the MMV set point will intersect the acceleration schedule as depicted by Point 2 and the FF will be reduced. Since the acceleration schedule is a function of RPM, any variation in RPM caused by the Propeller Governor will cause a variation in FF due to the acceleration schedule. As both the Propeller Governor and acceleration schedule compete to control the engine, via RPM or FF, an unstable operation, with oscillations in RPM and Tq, will occur.

Figure 19. Unstable operating mode. Photo: Honeywell.

It is possible to re-establish a stable operating mode under the acceleration schedule if the RPM is set higher using the RPM Lever or if the engine power is set lower using the Power Lever.

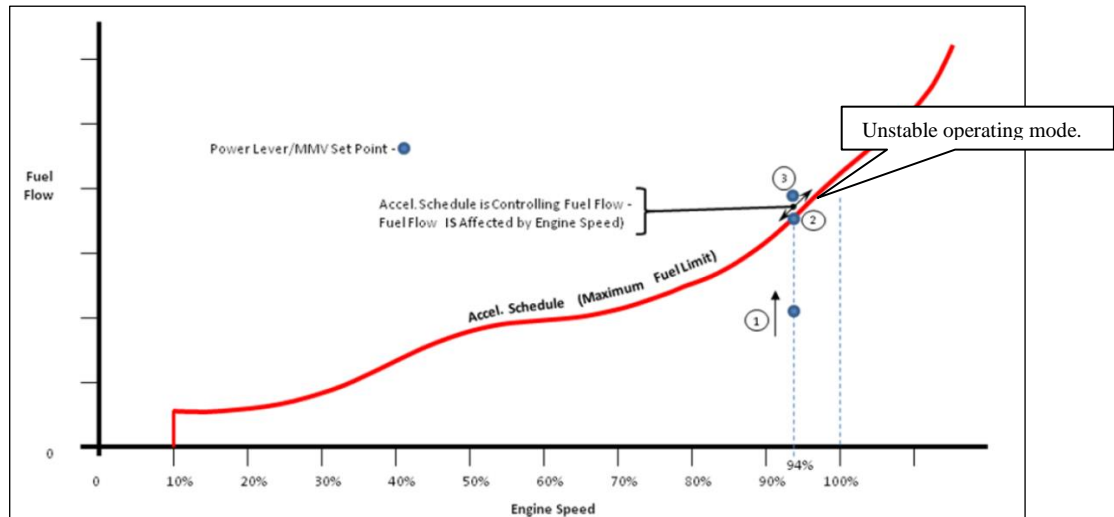
SHK establishes that the sequence of events and the similar oscillations in both engines is very much in line with what has occurred in previous incidents with this aircraft type when a high engine power is set whilst the engine RPM is too low; see Figure 21. This is supported by the fact that the amplitude of the oscillations increased drastically after a certain time; this indicates that the engines' TTL system was activated. This “characteristic” of the engine/propeller installation has been verified and is well known by engine and aircraft manufacturers.

Figure. 21. Unstable operating mode. Photo: Honeywell.

Everything thus points to the oscillations on both engines being caused by their RPM being too low for the high power output during the take-off.
